Site name	Site code	Date of visit	os x	OS Y	Latitude	Longitude	UTM
							31U 293634.76E,
Greenwich 4	GR4	31/07/2007	543982	174676	51 27' 10N	0 04' 15E	5684119.83N

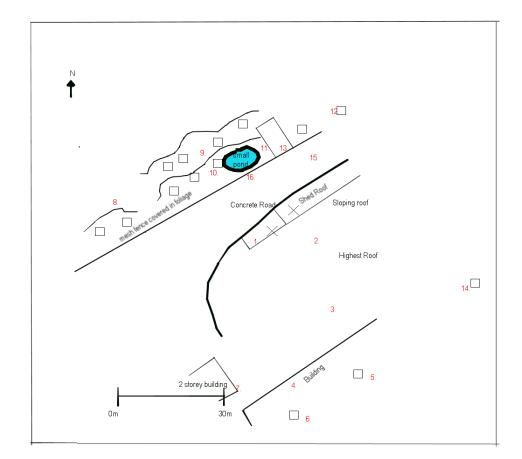
Plan view diagram (30 m radius)

Sketch key	Type	Detail	material	Doof motorial	
		20101	matenai	Roof material	View from station
1	Shed	N/a	Wooden half covered in foliage	Wooden	Nation 1. It
2	Building	1st storey roof	Light brick	Corrugated metal	Surrouri
3	Building	2nd storey roof	N/a	Corrugated metal	2 3100/02/12/14
4	Building	Behind the site	Light brick	grey clay tiles	A STATE OF THE STA
£	troo	Evergreen	N/a	N/a	31/07/2007 12:15
	3	2 Building  3 Building  4 Building	2 Building 1st storey roof  2nd storey roof  3 Building roof  Behind the site	2 Building 1st storey roof Light brick  3 Building 2nd storey roof N/a  Behind the site Light brick	1 Shed N/a covered in foliage Wooden  1st storey roof Light brick Corrugated metal  2 Building 2nd storey roof N/a Corrugated metal  4 Building Behind the site Light brick grey clay tiles

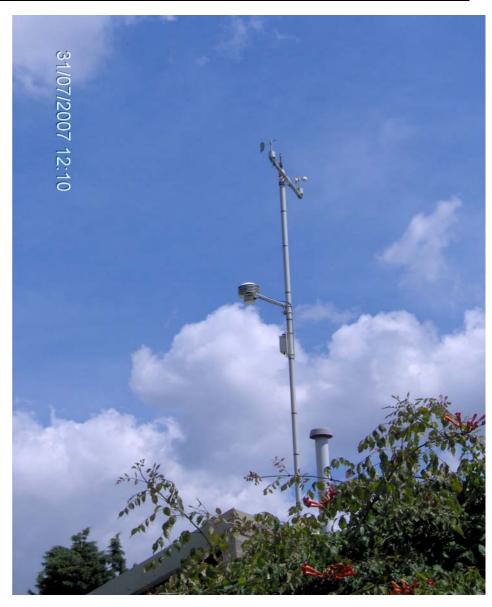
# Instrument image

True height		
Sketch key	Name	Variable	(m)	Concerns	
	Cup			Tall trees enclose the site undoubtedly	
а	anemometer	Wind Speed	9.47	affecting the wind speed.	
	Young wind	Wind		Tall trees enclose the site undoubtedly	
b	vane	Direction	9.47	affecting the wind speed.	
	TEO. 4	A. O. III		l	
С	TEOM	Air Quality	3.23	N/a	
				lug i i i i	
		Air		Windows on the second storey are	
d	N/a	temperature	N/a	very close to temperature sensor
