Site name	Site code	Date of visit	os x	OS Y	Latitude	Longitude	UTM
							31U 293634.76E,
Greenwich 4	GR4	31/07/2007	543982	174676	51 27' 10N	0 04' 15E	5684119.83N

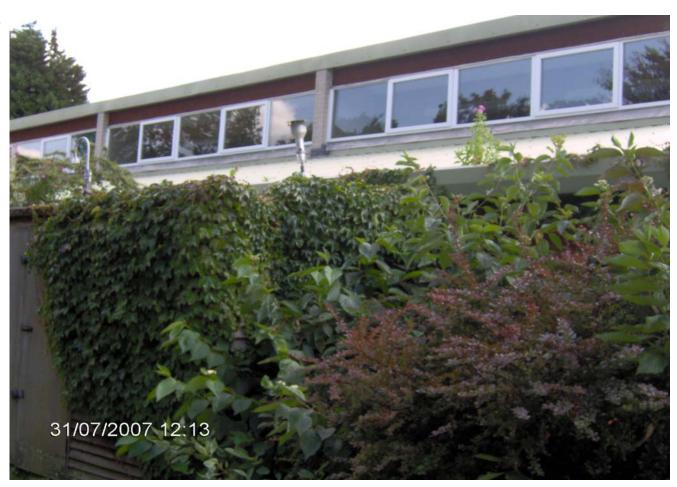
## Station photo

Meso (2 km radius)	Local (1km radius)	Micro (100 m radius)
In general it was a vegetated	There was a fairly busy road behind the	
area with open space,	vegetated are on which the site was	A pond about 3m away, dense tree cover.
amongst which residential	placed. There was generally a lot of foliage	Site on top of a building with a car park
areas were scattered.	all around.	nearby.

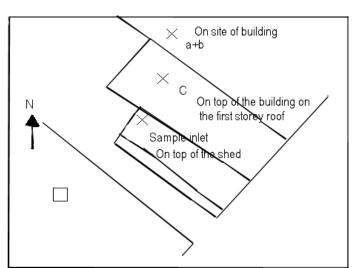
Instrument diagram (Plan view)

True height		
Sketch key	Name	Variable	(m)	Concerns	
	Cup			Tall trees enclose the site undoubtedly	
а	anemometer	Wind Speed	9.47	affecting the wind speed.	
	Young wind	Wind		Tall trees enclose the site undoubtedly	
b	vane	Direction	9.47	affecting the wind speed.	
	TEO. 4	A. O. III		l	
С	TEOM	Air Quality	3.23	N/a	
				lug i i i i	
		Air		Windows on the second storey are	
d	N/a	temperature	N/a	very close to temperature sensor
